German-Russian Folk Architecture in Southeastern South Dakota

State Historical Preservation Center
Vermillion, South Dakota

German-Russian Folk Architecture
in
Southeastern South Dakota

Michael Koop
Stephen Ludwig

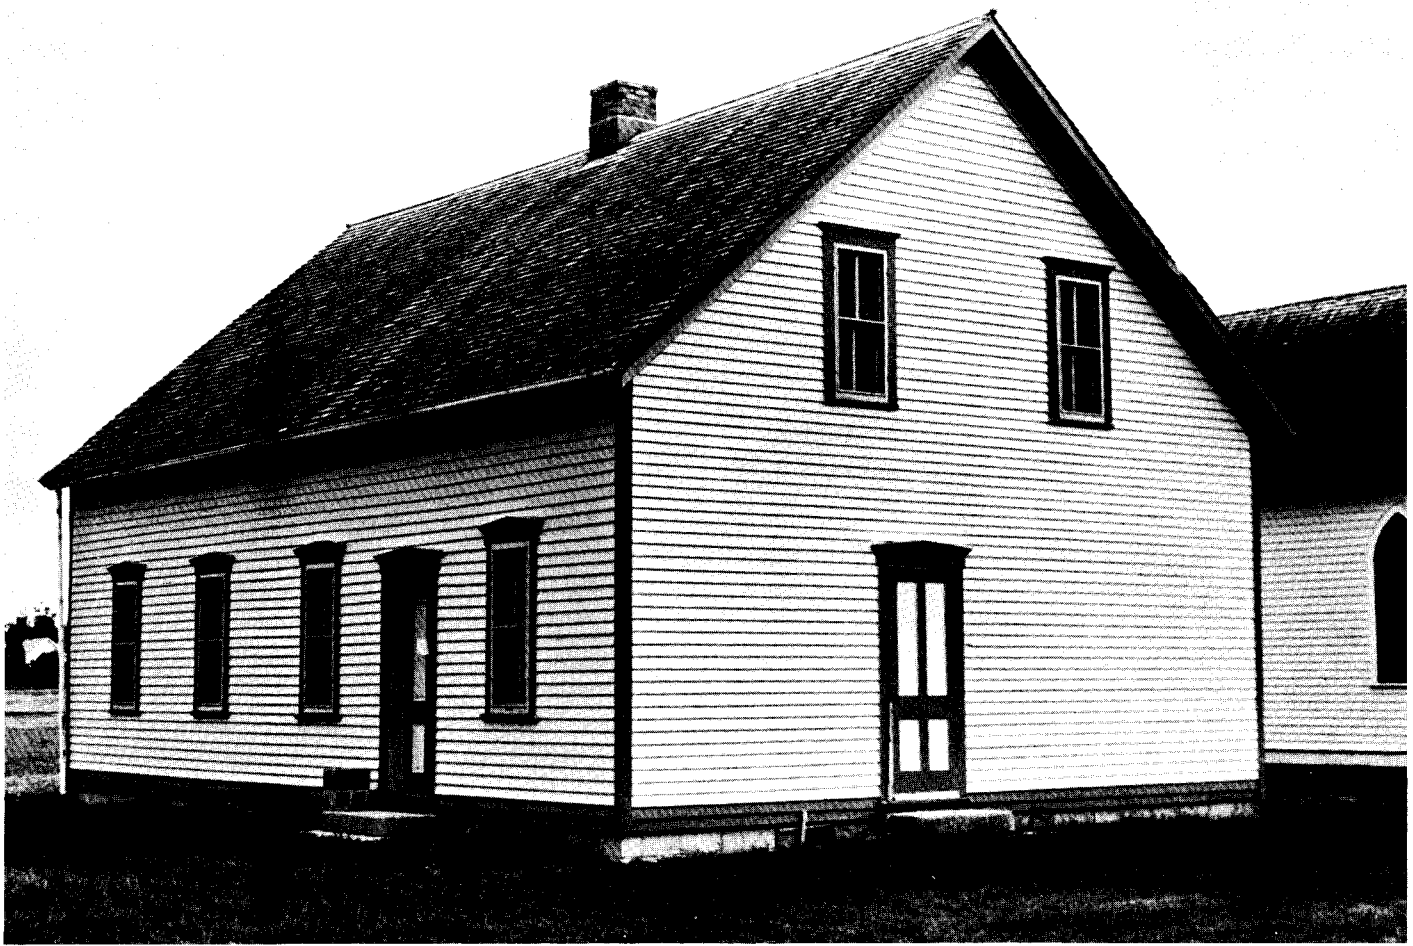
Fig 1. The Ludwig Deckert house on the Freeman College campus combines form with contemporary building materials. It was moved to the site from a rural setting and restored to its original condition by family descendants and local volunteers.

The dimensions of these houses vary somewhat, but range in length from 32’ to 58’ and 19’ to 26’ in width (Fig. 1). One story in height, the houses frequently have a barn or other addition attached to one gable end with a door

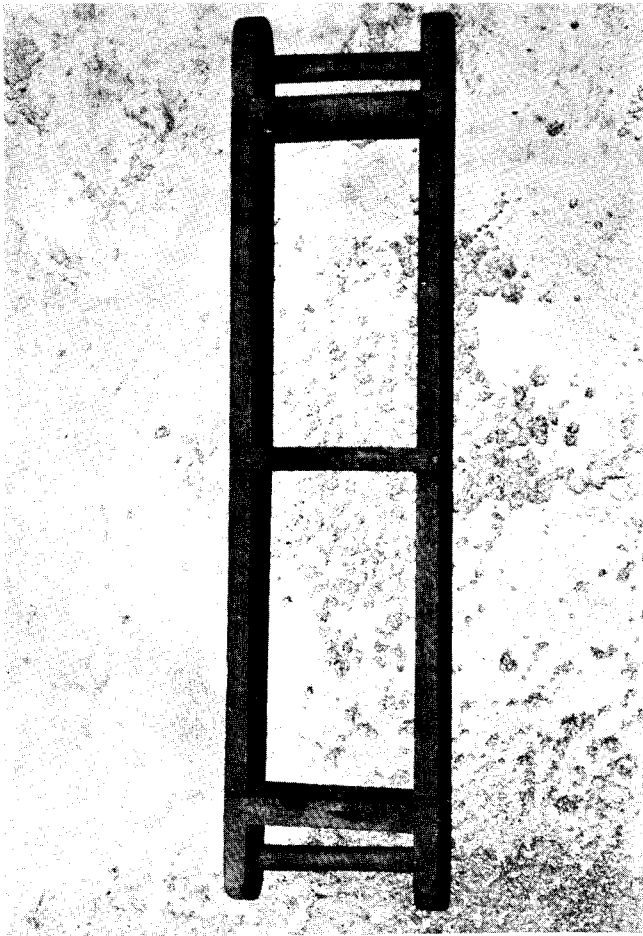
Fig. 2. This wooden mold used to make the clay batsa or sun-dried brick is on display at the Heritage Hall Museum in Freeman, South Dakota. Other similar molds are frequently smaller and have panels covering one side.

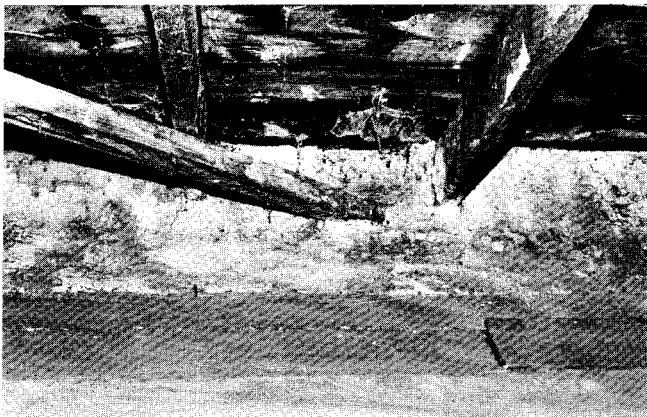
Fig. 3. A wind brace embedded into the uppermost part of a clay wall between two 2" x 4" rafters provides added roof support.

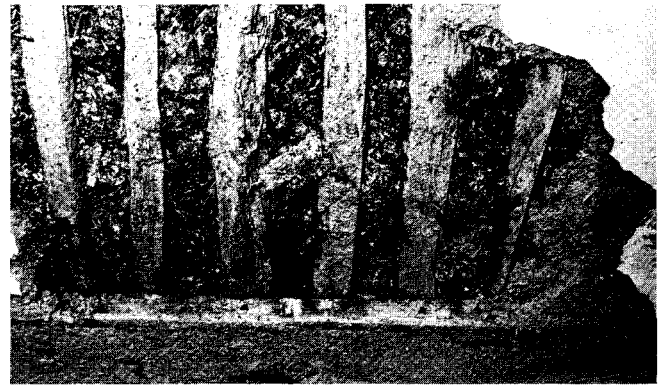
Fig. 4. This detail in the loft floor clearly shows the construction employed. Clay daub serves both as infill between the wooden staves and as a layer of plaster over which is applied whitewash.

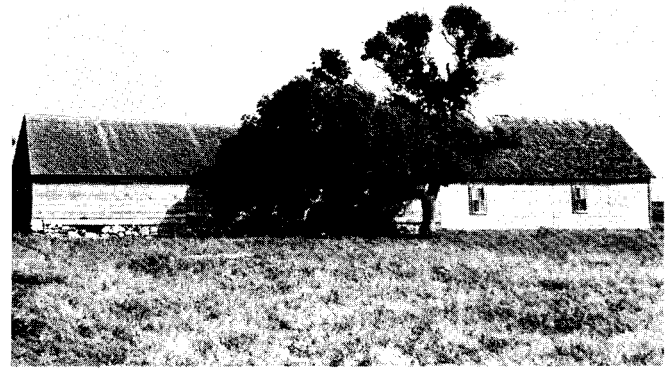
Fig. 5. Only two windows pierce the northwest facade of the Ziegler house-barn near Kaylor, an obvious energy saving feature.

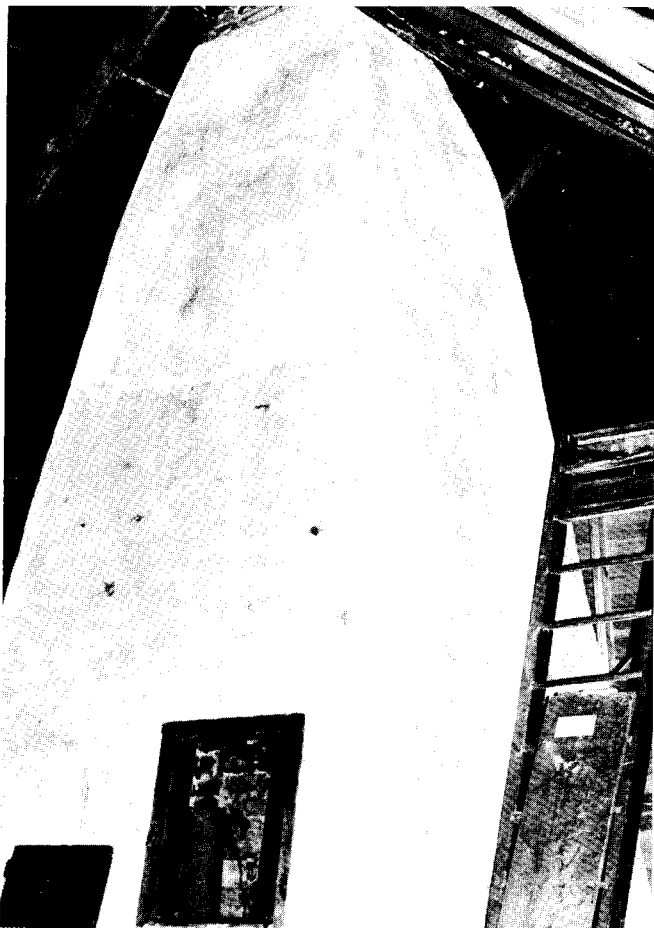
Fig. 6. A framed opening about 2' high at the base of the chimney allows meat to be hung inside for smoking; a thin layer of clay covers the batsa brick which can be seen through the opening. Kiln-fired brick is used at the top of the chimney where it meets the roof ridge.

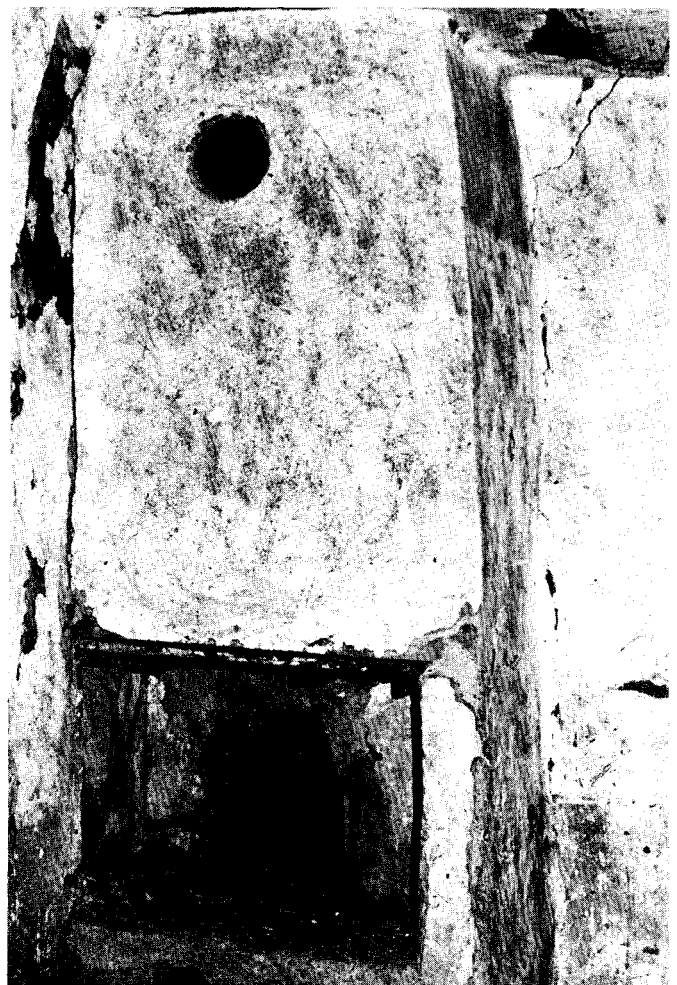
Fig. 7. Situated in the middle bay, this bake oven extends through the clay wall to a depth of 1'3".

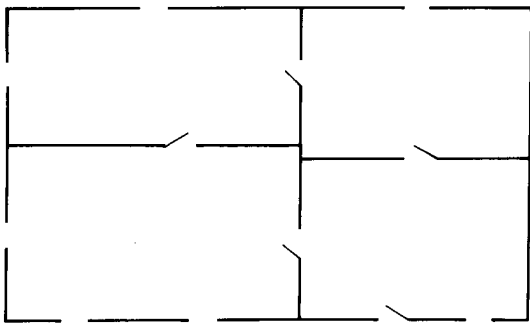
The two-bay, two-room deep floor plan is the most common and is found in five structures. Three to five openings pierce the main facade. The door is usually found to the right of center with two windows to the immediate left. While no pattern emerged regarding the width of the rooms, in four out of five houses the left bay was at least 2' longer than the right bay.

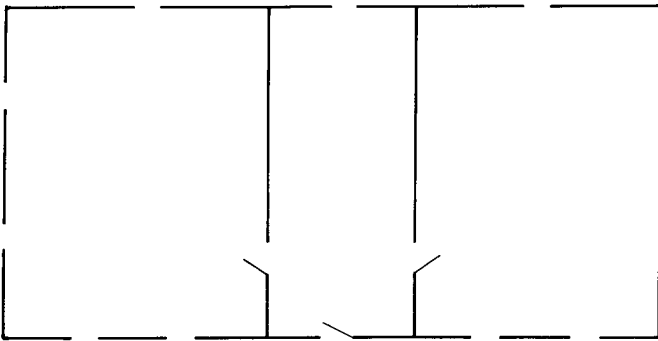
The second plan is the three-bay, one-room deep design. Three structures exhibited this floor plan. All had four to five openings on the main facade with the doorway towards the middle and two windows on each side. The middle bay in each of these structures is about 5' less in length than the outer bays. It is interesting to note that the overall width in each bay varies by only 4" for each structure.

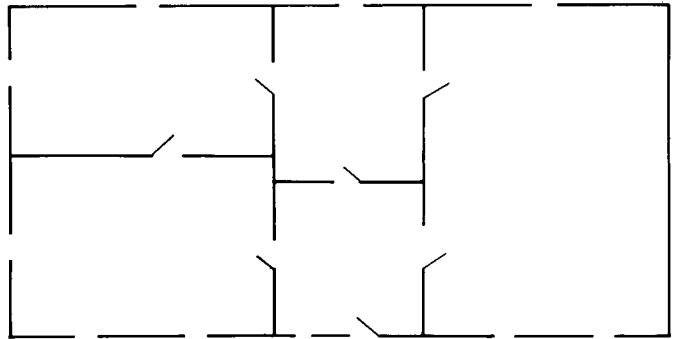
The three-bay, one and two-rooms deep plan is similar to the previous floor plan. These three-bay houses are divided laterally resulting in a five-room configuration instead of the three rooms. The front room in the middle bay, the entryway, is always the smallest room in the house, and the

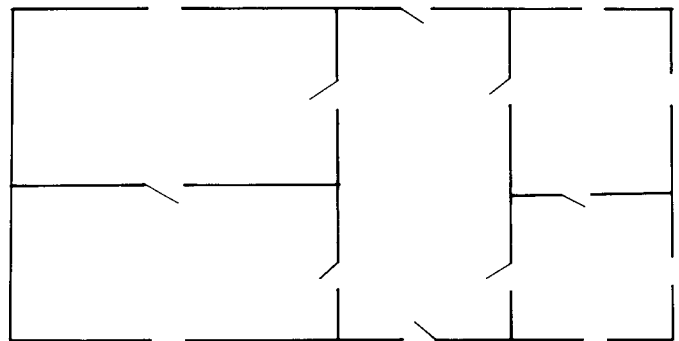
The three-bay, central hallway with double flanking rooms plan creates a relatively symmetrical structure. The nearly central hallway in these dwellings differs only slightly in both length and width. Rooms on either side of the hallway are divided laterally and are about equal in width, but vary greatly in length. Each structure has four to five openings on the main and rear facades, with the doorways facing each other. Perhaps the result of conscious planning or simply an accident, neither structure has openings on the north gable end but two each on the south gable end.

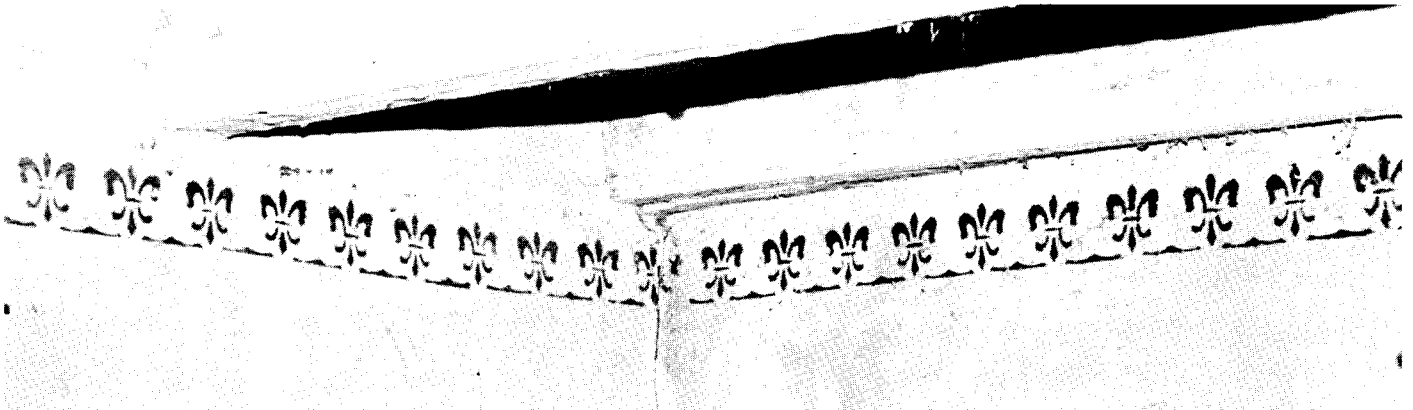
Fig. 8. This fleur-de-lis stencil pattern represents one form of decoration used by German-Russians in their homes.

Added decoration appears in the form of stenciling, (Fig. 8) spattering and wainscoting. The most highly decorated room appears to have been the parlor or front room of the first bay. An interesting paint pattern is found in one room on the floor at Site 14. Stenciling was evident at two sites (16 and 13) and appeared in one site as a freize. Several houses have wainscoting painted in the same traditional colors as above. Two houses have evidence of oil cloth covering which was whitewashed and later covered with a stencil-like wallpaper. The oil cloth serves the dual purpose of covering the clay walls and providing a layer of insulation.

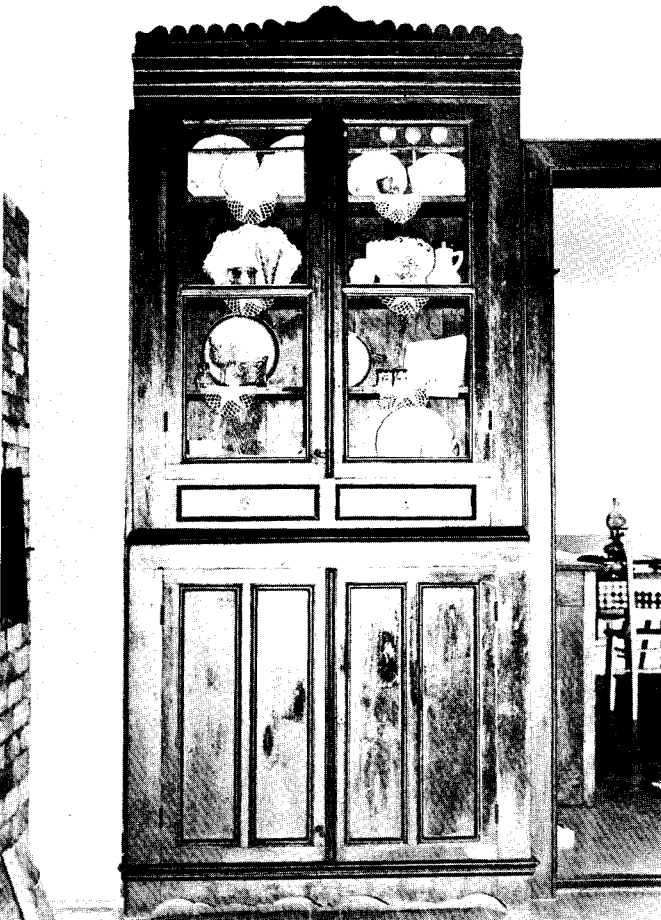
Fig 9. While not all recessed cupboards are as finely crafted and impressive as this one at the Deckert house, the common location adjacent to the furnace/bake oven indicated the persistence of a cultural tradition through time.

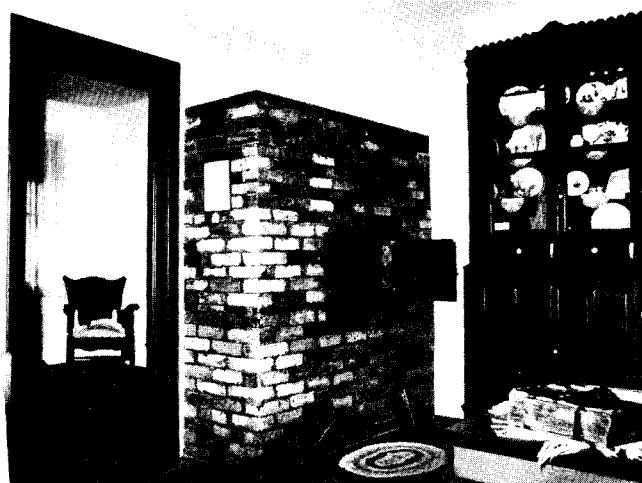
Fig. 17. The Deckert house furnace/bake oven acts as a divider between the parlor and bedroom. Baked goods were placed inside through the two small hinged doors.

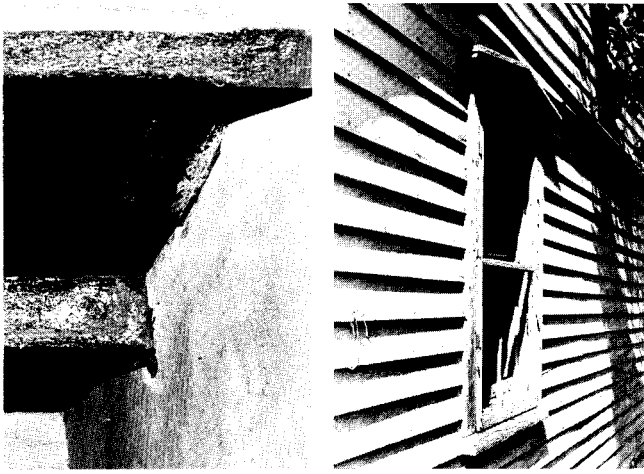
Fig. 19. A longer chamfer on the ceiling joist at the top of the photo may indicate that a furnace/bake oven was once located there. Another indication of the oven is a vertical crack in the far wall seen at the bottom left in the photo.

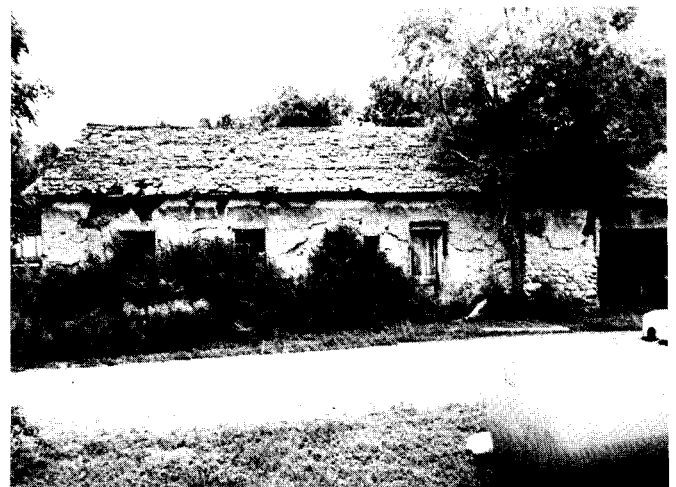
Fig. 21. The south elevation of the Gene Lang puddled clay and stone house is shown here.

Located on a working farm, the Lang house is situated adjacent to the present dwelling and enclosed on the north and west by a thick grove of medium-growth timber (Fig. 21). Presently used for storage, and suffering some decay, the structure reveals the methods employed in the construction of earthen buildings. Although the Lang house walls are not batsa brick as in the Kleinsasser house, there are some general construction similarities in the way the wooden framing system is used to both secure the loft floor and prevent the walls from spreading outward.

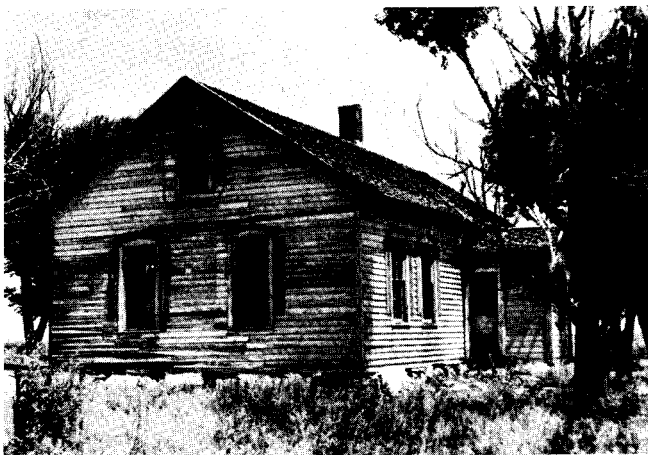
Fig. 24. The frame and batsa brick Rempfer-Wagner house in Yankton County is pictured here.

A building with numerous fascinating components, the Wagner house is part of an abandoned farmstead (Fig. 24). The structure is frame with batsa brick nogging on all external walls. The exterior wall consists of two layers of horizontal wood siding, the outer layer being clapboard and the inner layer being simply rough-sawn lumber attached with cut nails. Under the siding 2" x 4" vertical studs are spaced about 16" apart on center. Between the studs batsa brick measuring about 12" long and 5"-6" wide is stacked and bonded with a clay mortar. The interior wall is made with a series of horizontal wooden lath strips approximately 2" wide nailed onto vertical studs over the batsa brick nogging. Over the lath mesh a thin layer of clay/straw mixture approximately ½" thick is applied. The final interior finish is a ¼" thick, plaster-like covering.

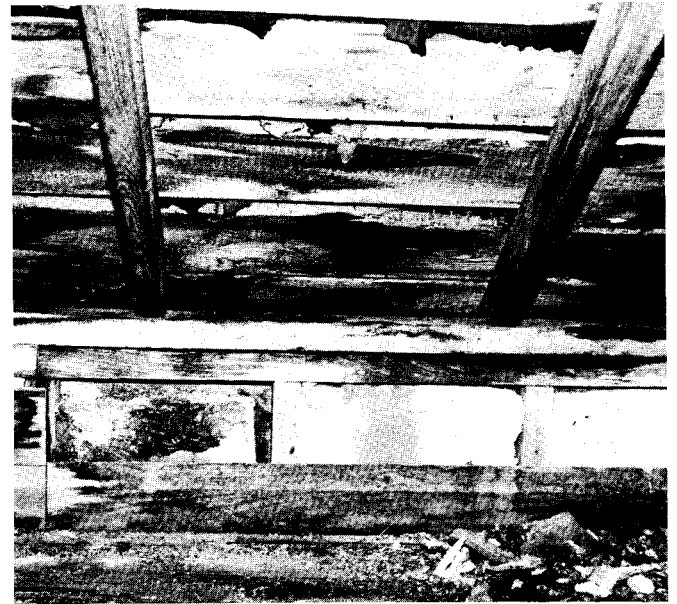
Fig. 25. This detail taken in the loft shows batsa brick infill between vertical wall studs; horizontal tongue and groove boards partially cover the bottom of the bricks. The distance between each 2" x 4" stud is 16".

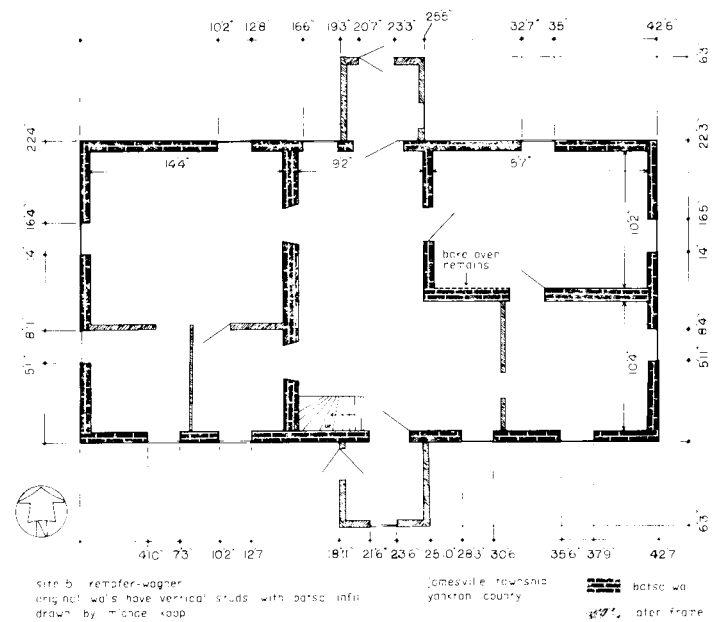
Fig. 26. Site 5 is the only surveyed house which has a vorhäusl on both the north and south facades. Comparison with Site 9 shows similarities including room arrangement, location of furnace/bake oven and exterior dimensions.

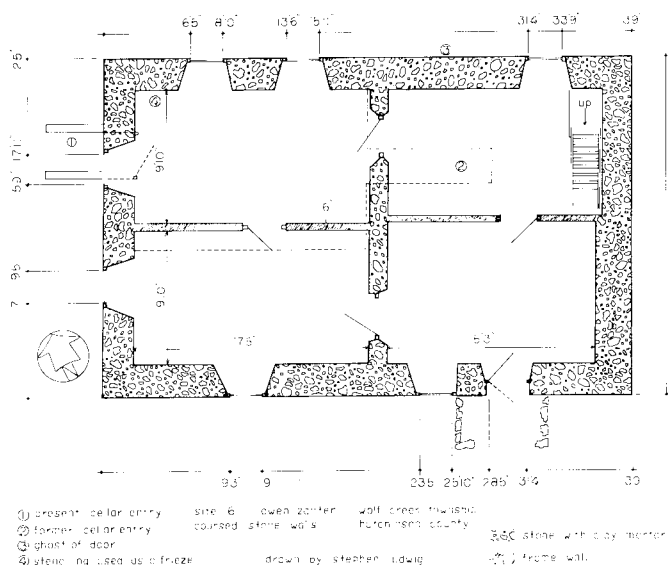
Fig. 27. In this plan of the Zanter house, evidence can be seen of a bake oven in the rear, right bay room.

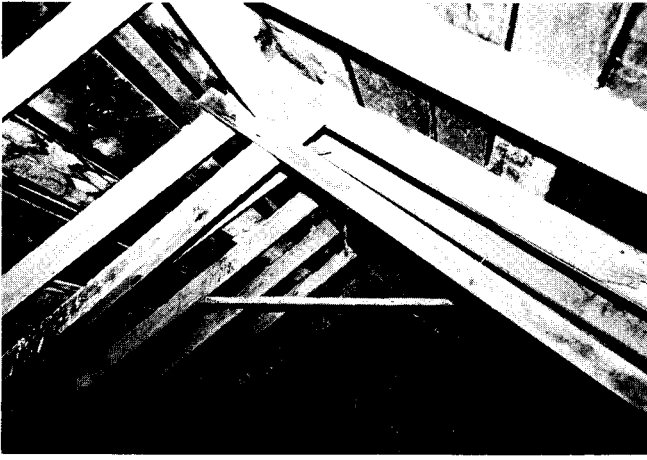
Fig. 30. Two of the six extra beams adjacent to rafters are notched below the squared ridge pole.

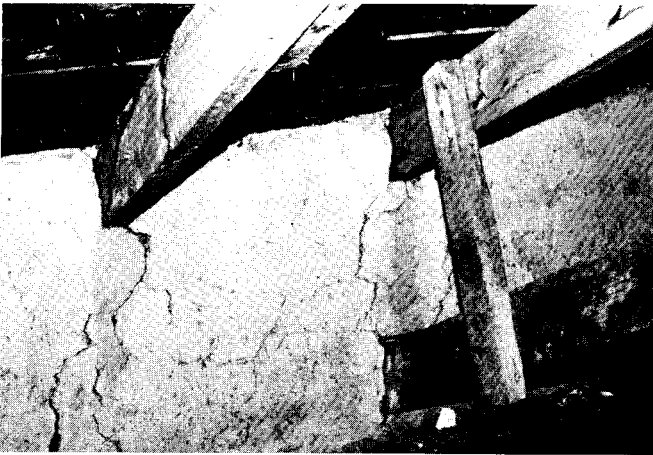
Fig. 31. This detail shows two rafters embedded into the top of the clay knee wall. An extra 4" x 4" beam placed just above the loft floor is attached to the rafter by a vertical knee brace.

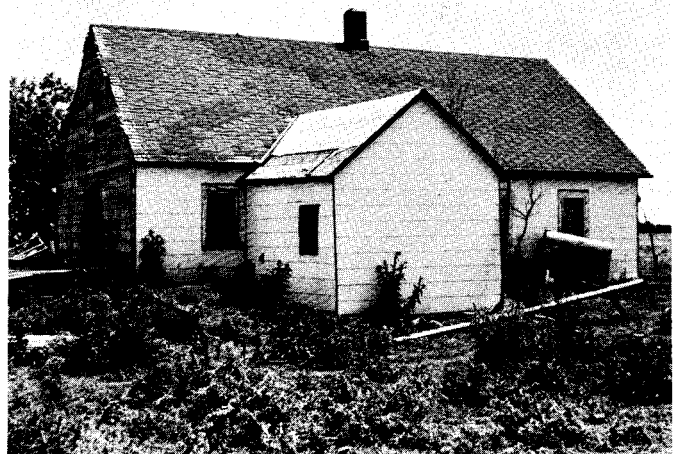
Fig. 32. The remains of the attached barn can be seen at the left of this photo of the Hofer house.

Built in 1896 as a house-barn, (Fig. 32) the Michael D. Hofer site was constructed by, or for, a Prairie Hutterite. Since the site was originally settled in 1874, this may be the

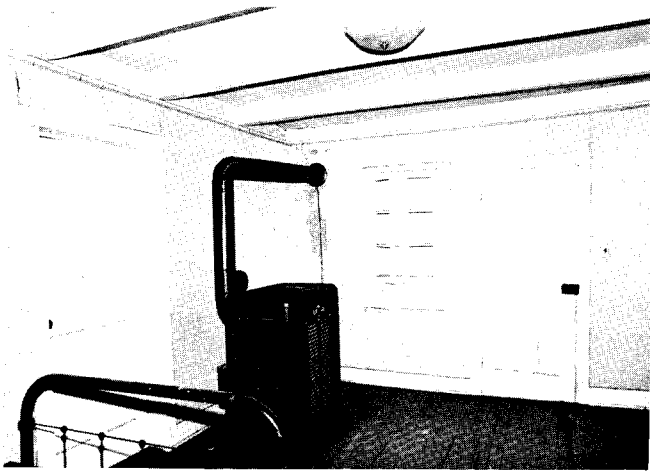
Fig. 34. Although no evidence of a furnace/bake oven was found at Site 8, the same general spacing of doors and the location of a recessed cupboard indicate a typical German-Russian house with furnace/bake oven. Note the chamfer on the exposed stringers.

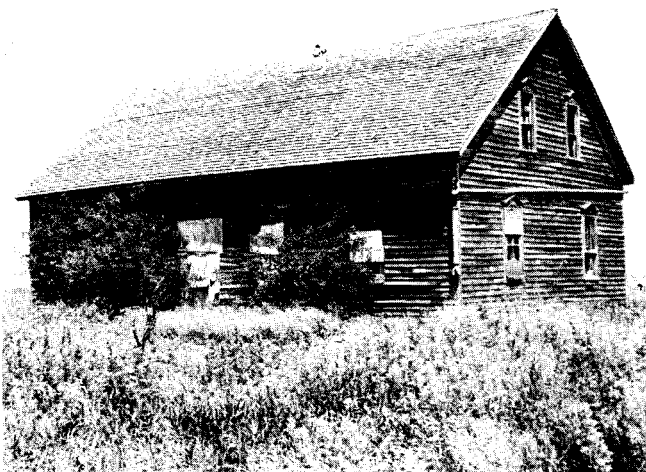
Fig. 35. The Jacob Hofer frame house was built in 1892.

According to its present owner, Jacob Hofer, the Hofer house was built the year of his birth 1892. Mr. Hofer's parents came to South Dakota from the Crimea in South Russia and in 1878 settled on this site. Built with lumber from Yankton and replacing the original "sod" house (Fig. 35), this balloon-frame structure with beveled siding is located north of Freeman, abandoned and deteriorating.

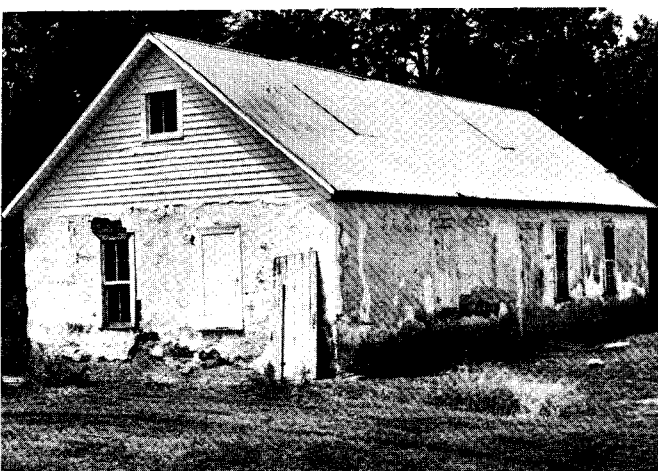
Fig. 37. The Czech-built Sedlacek house closely resembles a typical German-Russian dwelling.

One of the two surveyed sites built by Czechoslovakians is (Fig. 37) Site 10. Thomas Cihak, the original owner, is believed to have been Bohemian and Catholic, as is the present owner. While the exact date of construction has not been determined, circa 1870-1879 is a reasonable estimate.

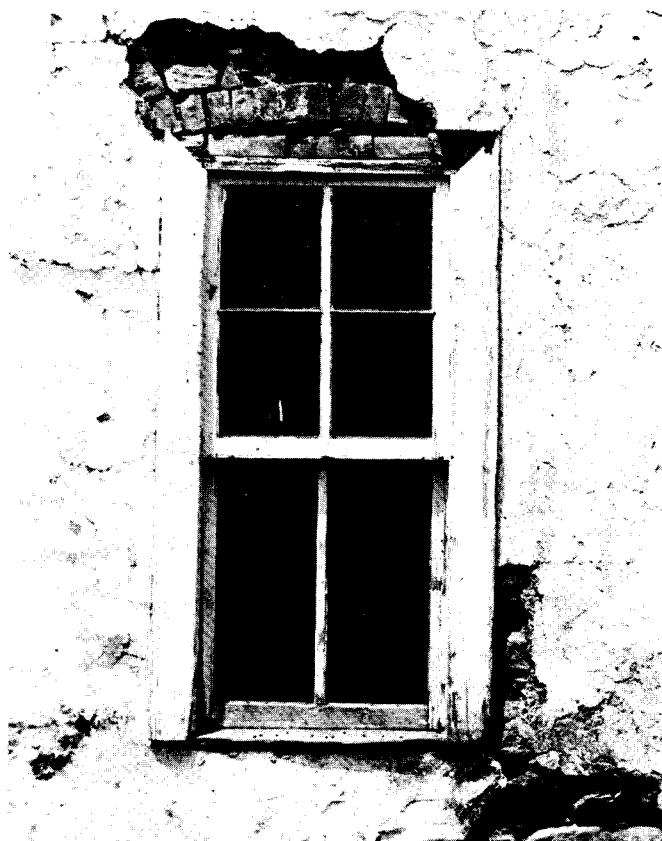
Fig. 38. What appears to be a completely stone masonry wall in the Sedlacek house actually contains a brick jack arch above the double-hung sash window.

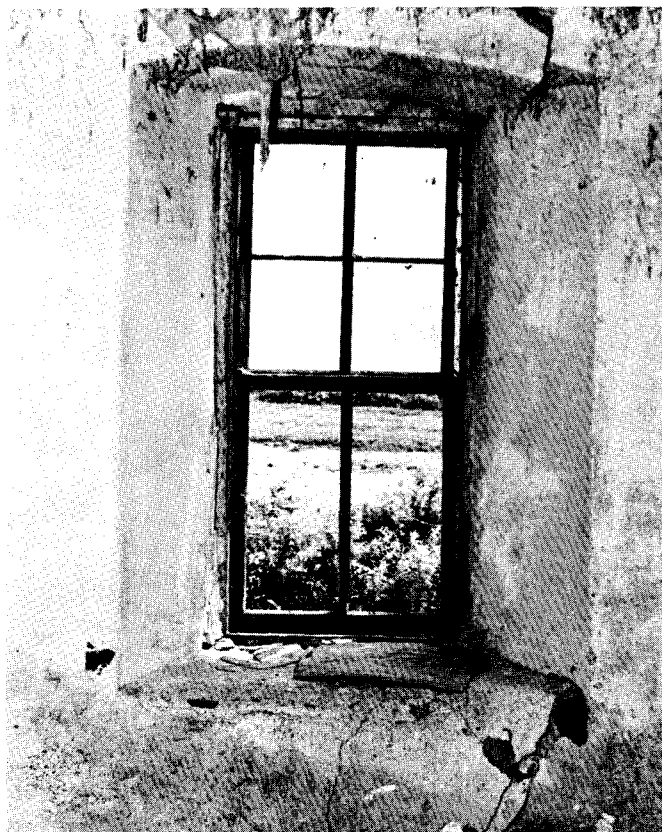
Fig. 39. An interior view of the previous window shows clearly a continuation of the arch. Note the wall thickness and angled window opening which takes full advantage of solar heating.

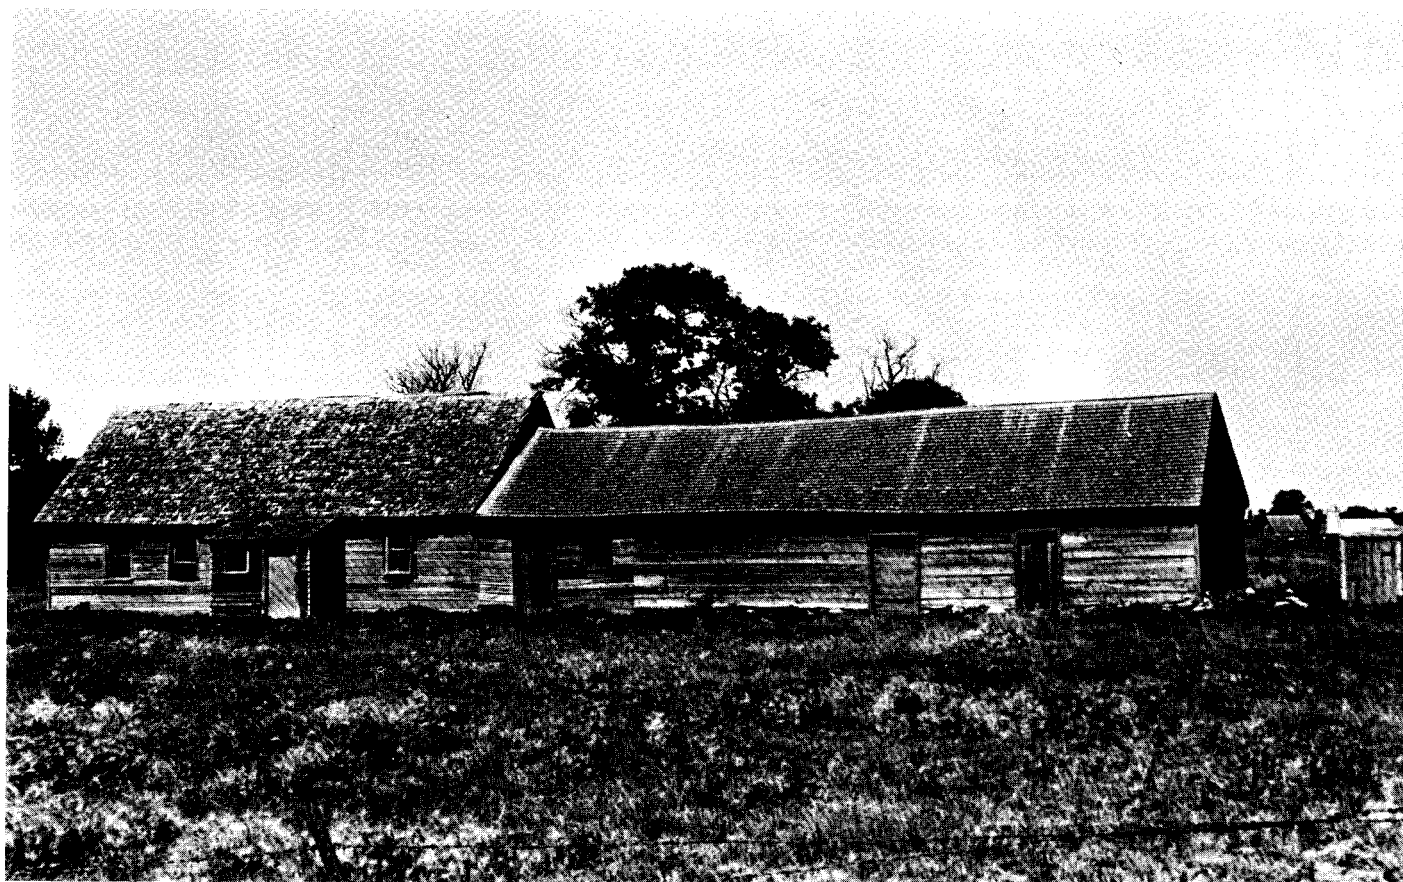
Fig. 40. The Edwin Ziegler house-barn resembles a simple frame structure. The house, however, has batsa brick infill; in addition, the barn is made of batsa with a clay veneer. Note the location of the vorhäusl and the root cellar to the right of the barn.

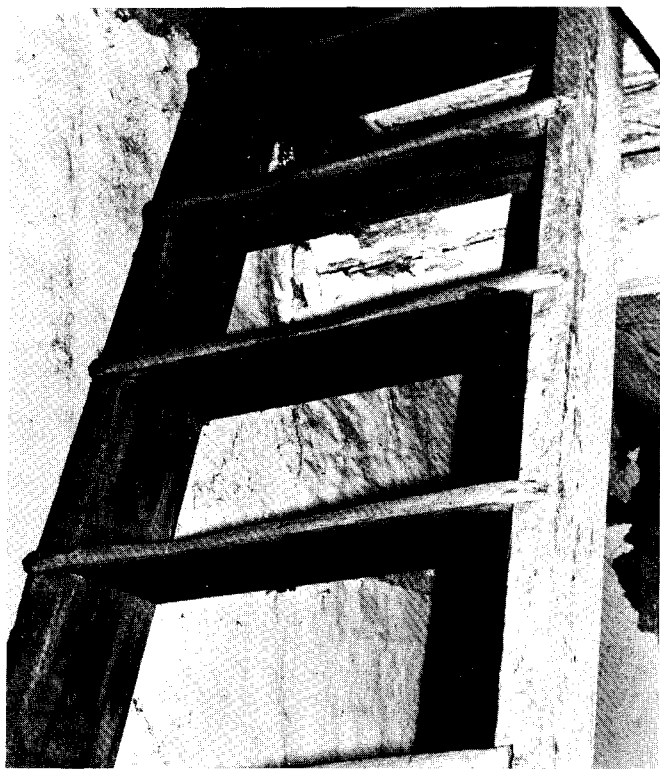
Fig. 42. Pictured here is the ladder to the loft at the Ziegler house-barn. Sturdy and well-constructed, these ladders with mortised steps are found commonly in German-Russian homes.

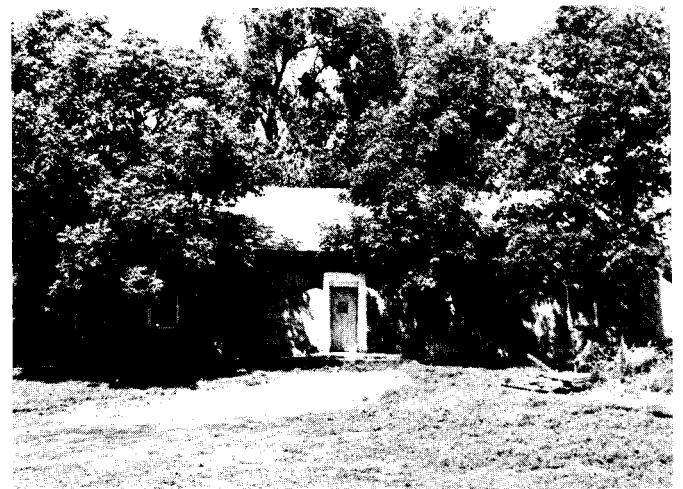
Fig. 44. The east elevation is shown in this photograph of the Phillip Lang house.

Located on a working farm adjacent to Site 4, the Phillip Lang site was built in 1873 (Fig. 44). It appears to be constructed of puddled clay and stone although only a small portion of the west wall can verify this assumption. The house is currently used for storage but is kept clean and well maintained by family members.

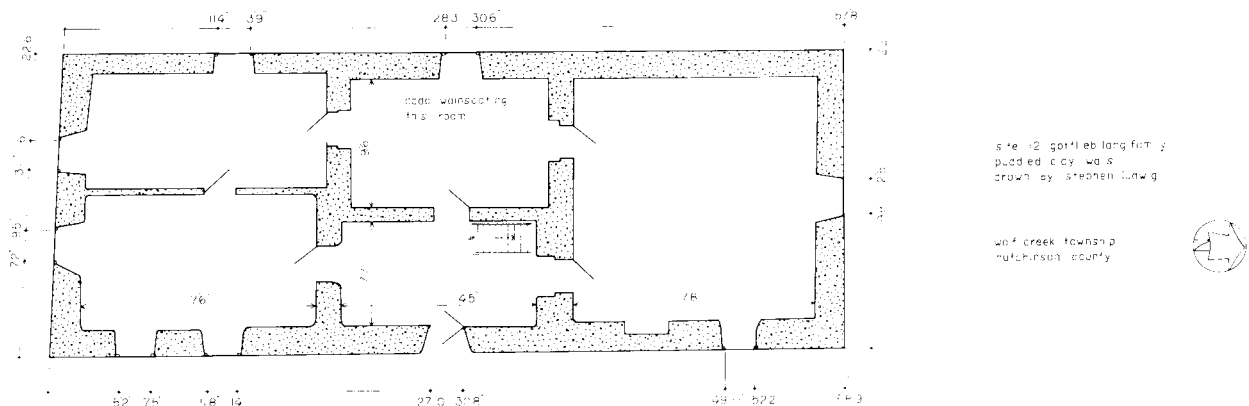
Fig. 45. The right bay of this structure was the original dwelling; one year after its completion the left and middle bays were added, creating the unusual length of this house.

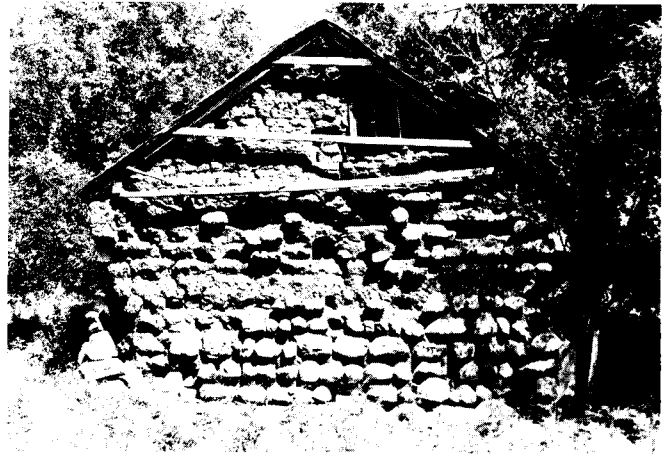
Fig. 47. Puddled clay and stone are used to the eave, while batsa brick fills the gable in the Mayer Rademacher house. Puddled clay acts as the load-bearing element in this wall; the stones which have fallen out are simply infill.

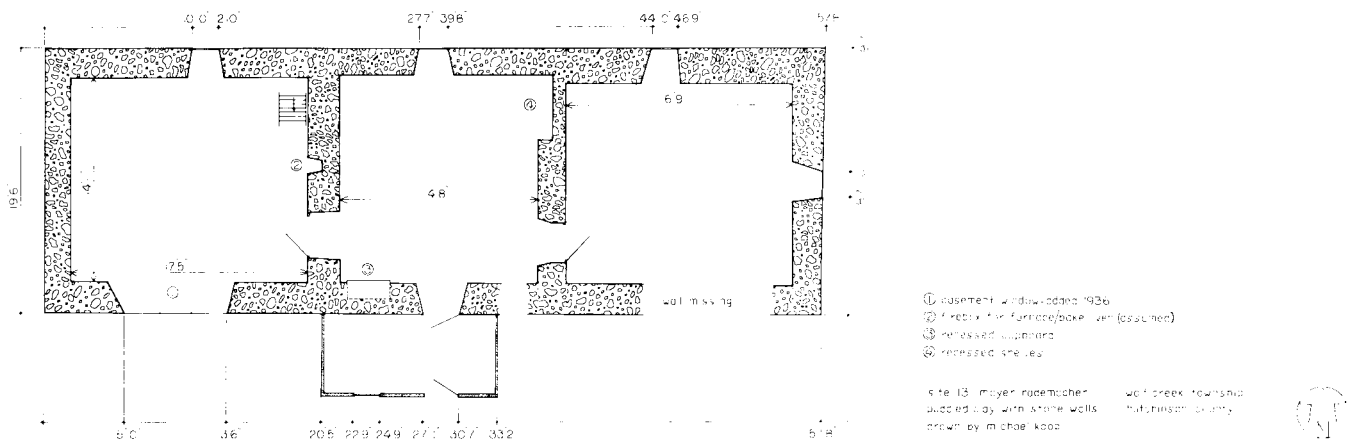
Fig. 48. Shown here is the Mayer Rademacher house. A barn was originally attached to the west end of the house. This is an unusual location for the barn and is the only example in the survey.

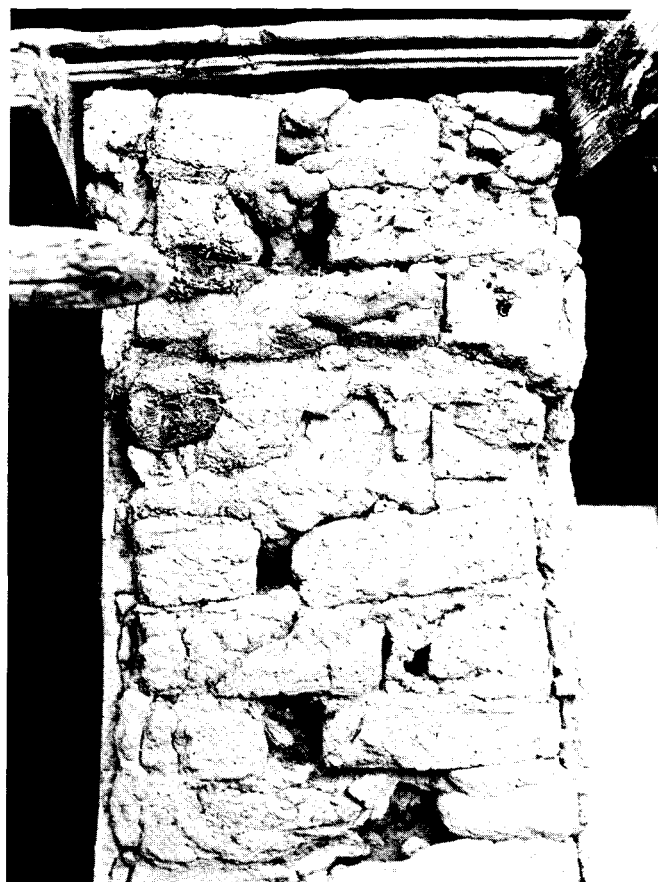
Fig. 49. A section of a wall at the Rademacher house shows the batsa brick, clay mortar and a thin veneer of clay and whitewash.

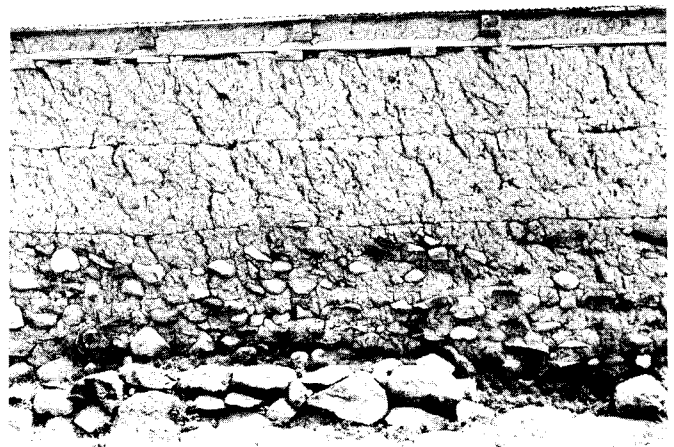
Fig. 51. Distinct layers of puddled clay are visible on this barn at the Grosz farm. Stones mixed with puddled clay occur regularly toward the foundation. Note the horizontal wall plate and shims embedded between the top tier of clay and the floor joists.

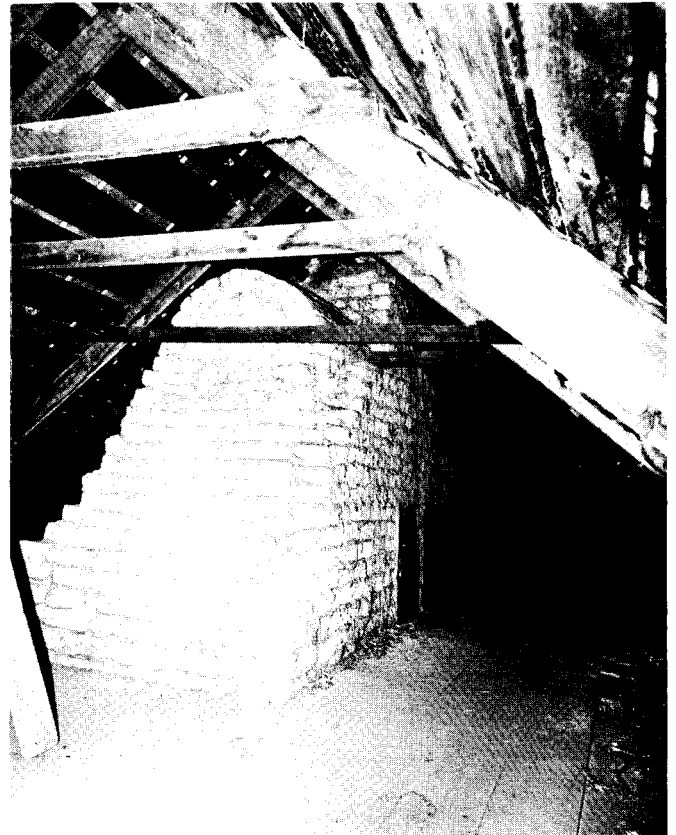
Fig. 53. Martin Grosz, the grandfather of the present owner, built this decorative arch on this batsa chimney. This massive chimney has a small wooden door on one side. The meat to be smoked was placed in the chimney through the door.

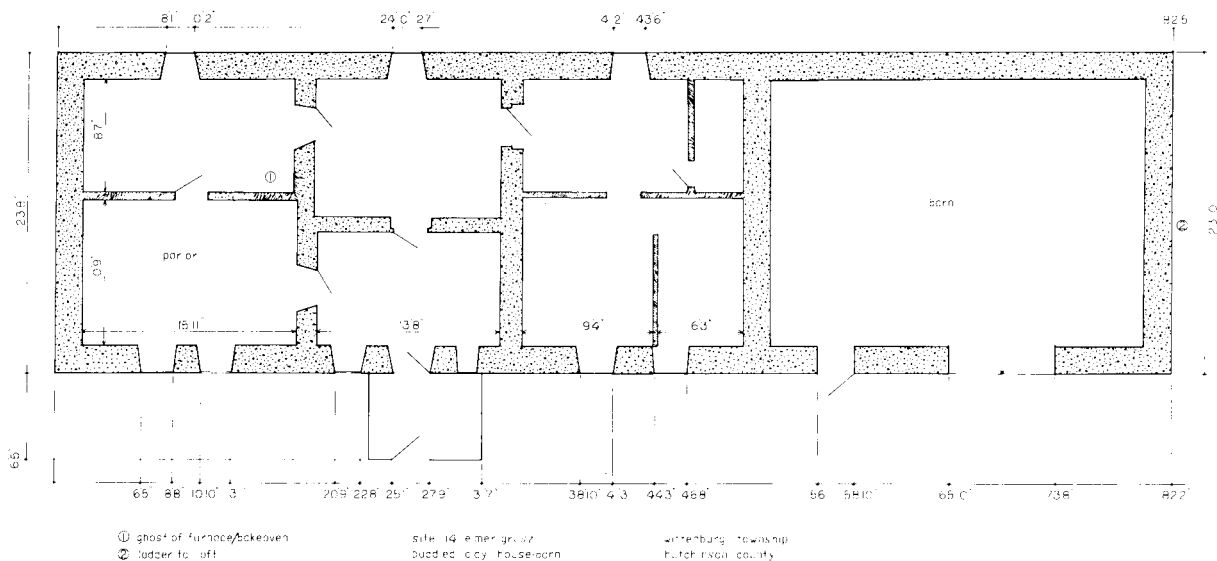
Fig. 52. A ghost of a furnace/bake oven appears in the left bay of the house. The size of both the central kitchen area and the batsa chimney strongly suggest a walk-in kitchen at one time. Note that entry into the loft is gained by the ladder at the gable end.

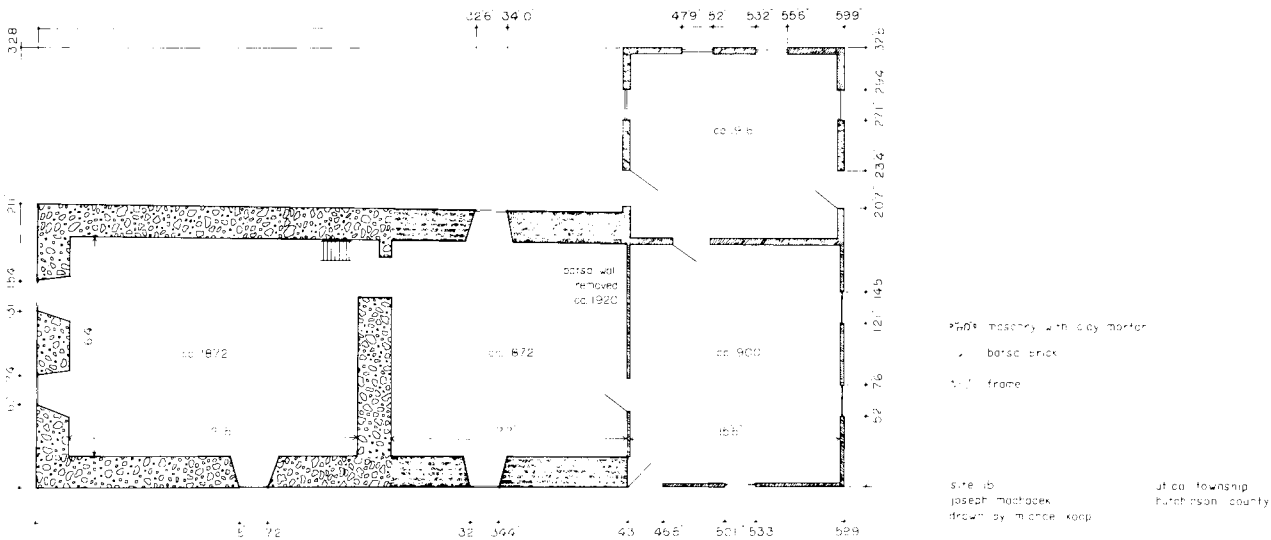
Fig. 55. Built one bay at a time, the Joe Machacek house uses three different construction materials—batsa brick, masonry and frame.

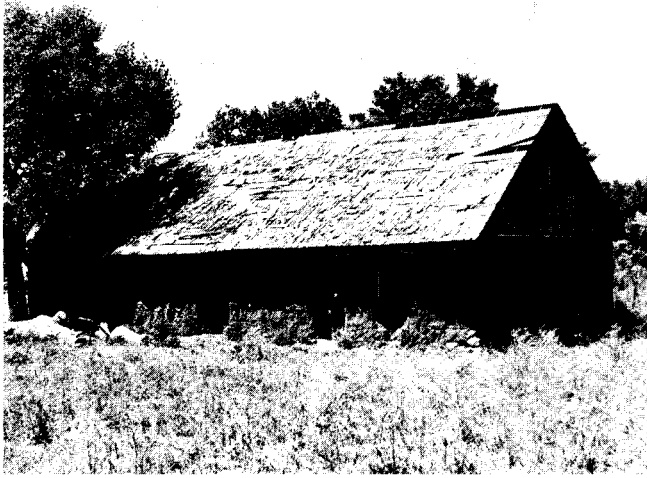
Fig. 57. Pictured here is the Schmidt house, a rammed earth structure. The light-colored material on doors, windows and under the eave is a clay veneer applied over the rammed earth walls. The clay tiers are easily distinguished; note vertical board and batten siding in the gable and projections at the top of the clay which are used to support a rain guard.

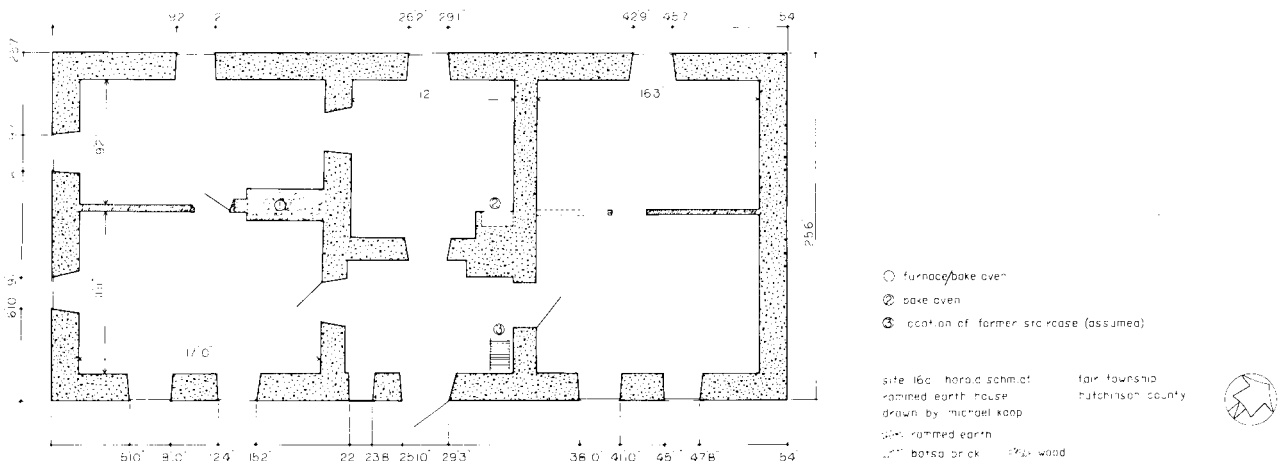
Fig. 58. Two bake ovens at the Schmidt house feed into a long, narrow batsa chimney which spans across the middle bay of the house. The weight of the chimney is supported by the axial dividing wall in the central bay.

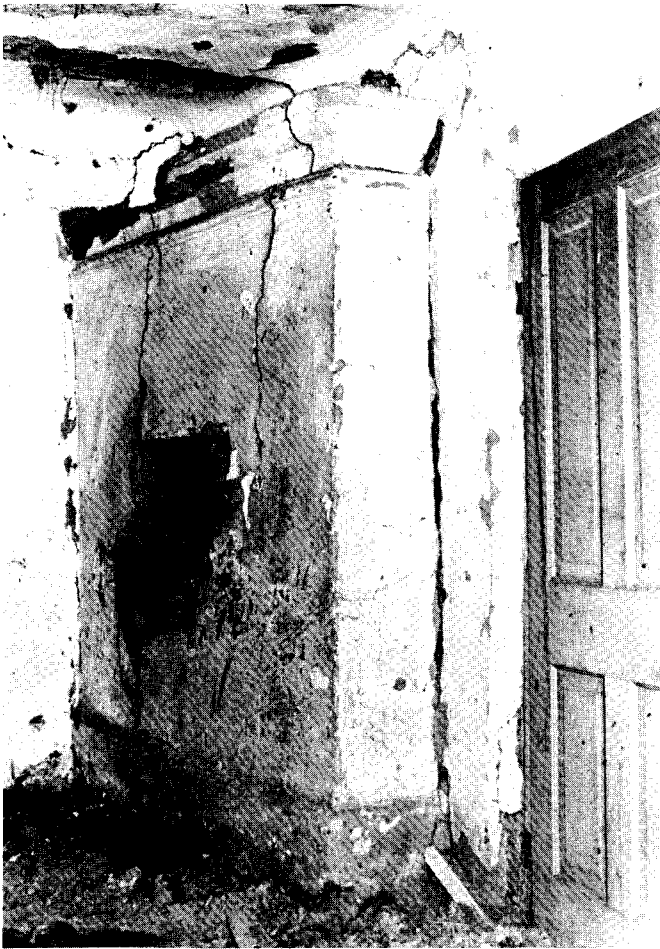
Fig. 59. Pictured here are the crumbling remains of the furnace/bake oven at the Schmidt house. Note the clay mold at the top of the oven.

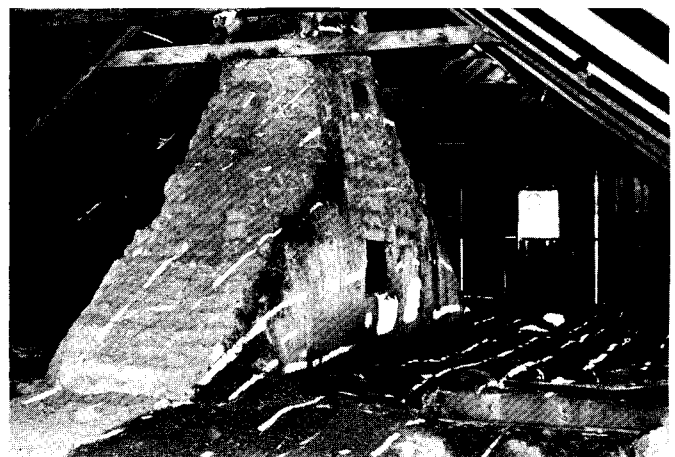
Fig. 60. This batsa brick chimney is very similar to the Grosz chimney at Site 14. Note the small meat smoking opening near the loft floor.
