German-Russian Folk Architecture in Southeastern South Dakota

State Historical Preservation Center
Vermillion, South Dakota

German-Russian Folk Architecture
in
Southeastern South Dakota

Michael Koop
Stephen Ludwig

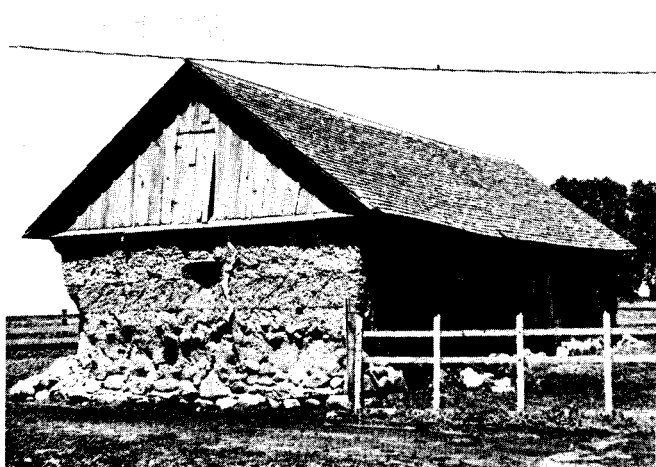
Fig. 61. This rammed earth barn similar to the Schmidt house displays the various layers of the clay in the wall.

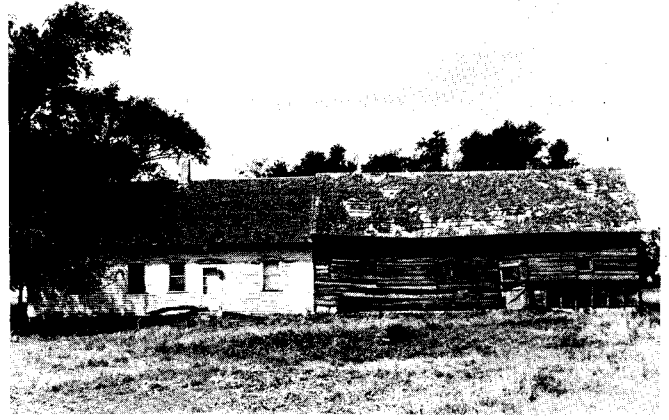
Fig. 64. Built entirely of wood is the Joe P. Gross house-barn. Note the location of the windows and door.

Part of a recently abandoned farmstead which is now in estate, this house-barn (Fig. 64) is located just off a township

road with the long axis running due north-south. The land was homesteaded by Matthew Meyer and this portion sold to Paul C. Gross. A Prairie Hutterite, Paul was the father of Joe P. Gross. Clarence Gross, the administrator of the estate also said that the barn which is attached to the house was built concurrently with the dwelling. The barn connects only superficially with the house and is not truly built as one unit.

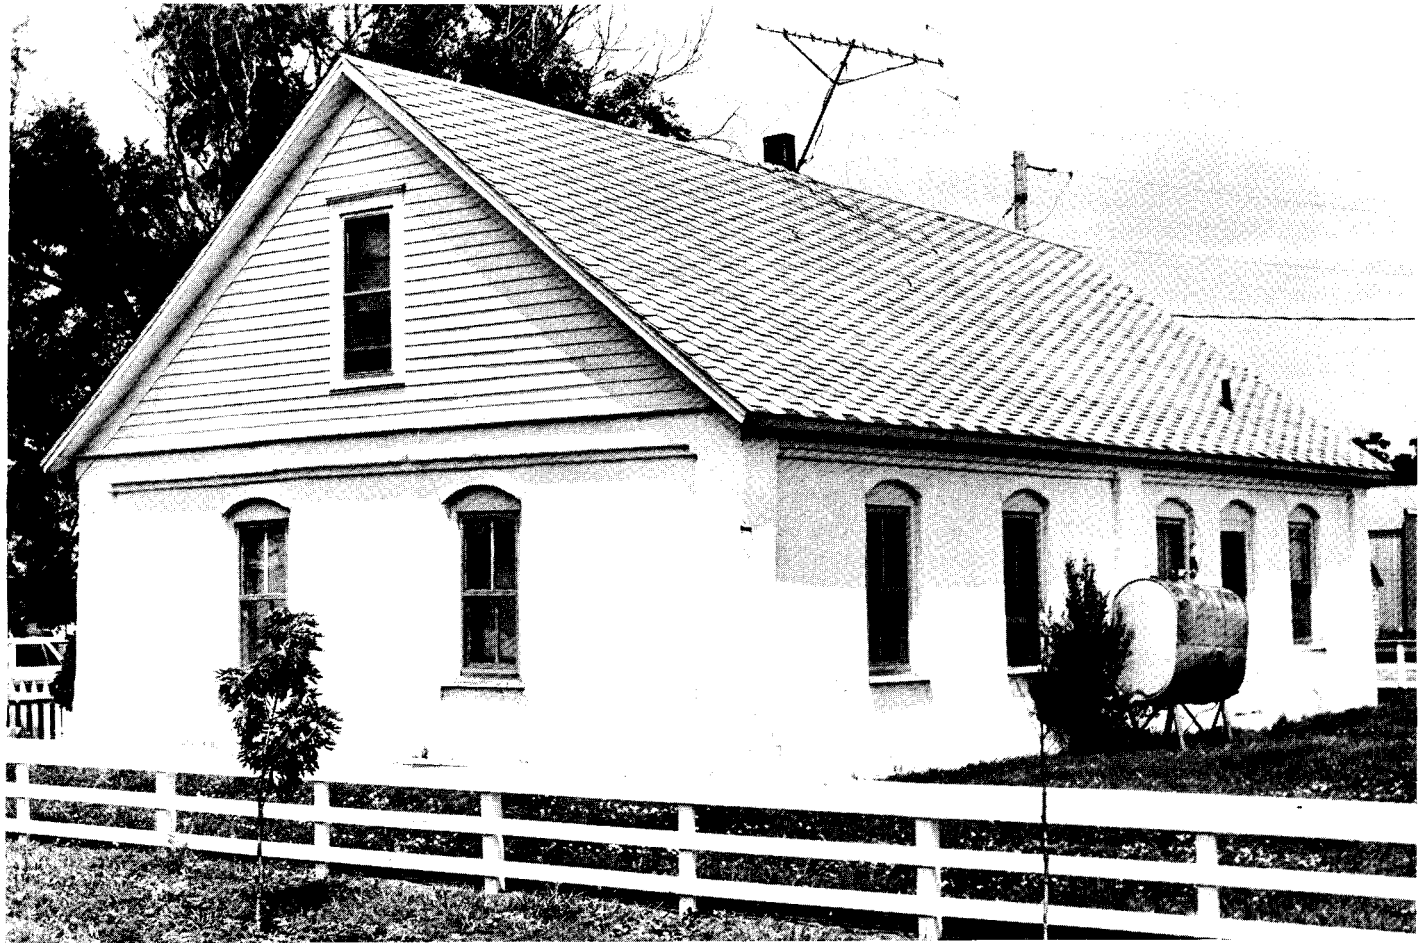
Fig. 65. The Paul Pullman house is built of locally-made, kiln-fired brick. Arched windows, whitewash and pilasters are characteristics found in Ukrainian houses.
